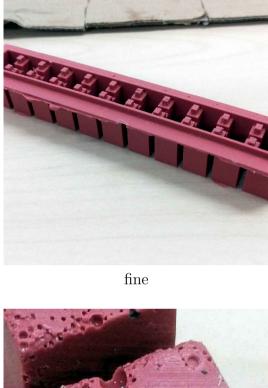
too much air trapped in the elastomer

holes at functionally relevant areas

mold was opened too early
