Modifying the Bank Erosion Hazard Index (BEHI) Protocol for Rapid Assessment of Streambank Erosion in Northeastern Ohio

Sara E. Newton¹, Deanna M. Drenten²

¹Natural Resources, Cleveland Metroparks

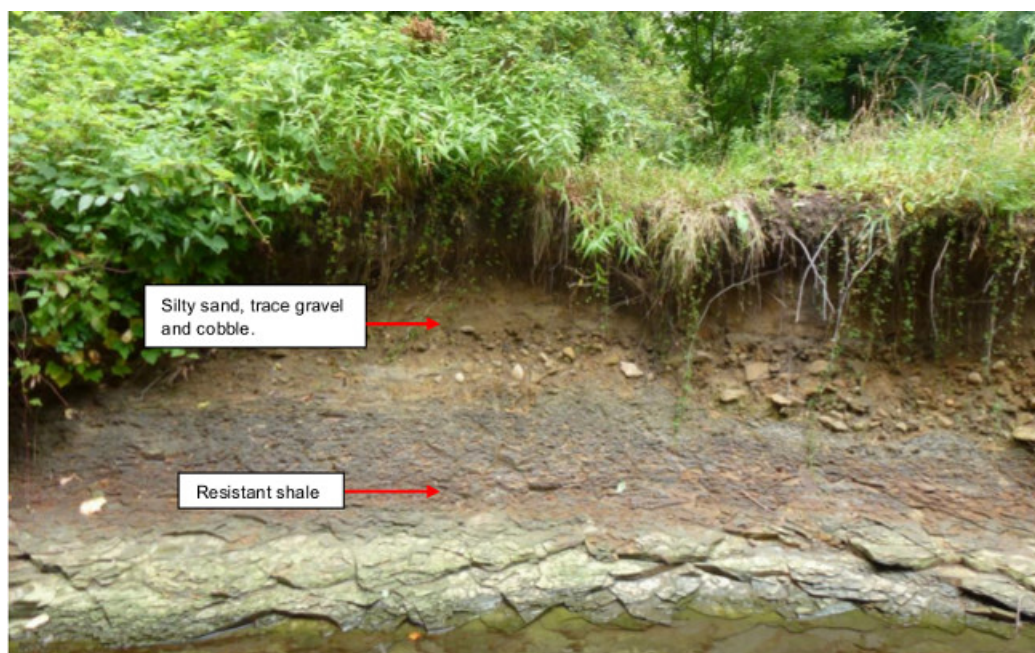
Figure 4. Bank Material Metric. Adjustments can be made based on the erodibility of the material. A mixture of material, as shown in the figure is often found in stream systems so an average score would be more appropriate.

12. Make bank material adjustments based on the erodibility of the material.
 1. Subtract up to 10 points for material that does not have a high rate of erodibility (*i.e.*, cobble). Add up to 10 points for extremely erodible materials (*i.e.*, sand). A mixture of material (*i.e.*, sand with some gravel or silty sand with trace gravel) is more often found in stream systems so an average score would be more appropriate (**Figure 4**). This is not a mandatory adjustment. See **Figure 4** In Results Section.

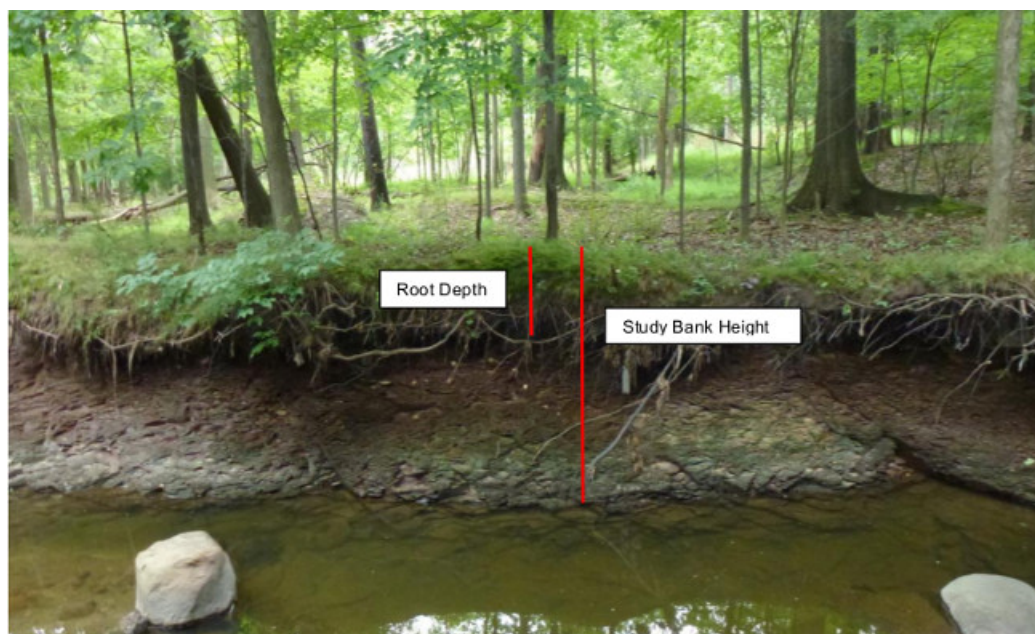
Figure 5. Riparian Root Depth Metric. The ratio of the average root depth of plants to the study bank height, expressed as a percentage. For this bank, roots grow to a depth of approximately 30% of the entire bank.

13. Determine the ratio of the average root depth of plants to the study bank height, expressed as a percentage, to estimate the adherence of bank material by vegetation (**Figure 5**).

3. Estimate a percentage based on the entire bank, then use the "BEHI Score Chart" to record the score for that percentage on the data sheet. See **Figure 5** in Results Section.

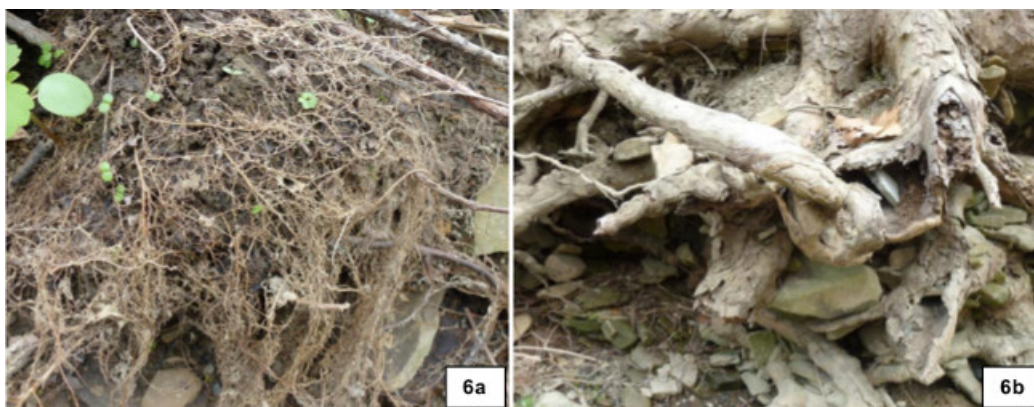
Figure 6. Root Density Metric. Small, fibrous roots, as shown in (A) can be very dense and provide greater soil retention compared to large, tap root systems shown in (B). [Please click here to view a larger version of this figure.](#)

14. Determine the root density by making a visual assessment of the amount of bank composed of root material, expressed as a percentage.
 1. Do not consider roots that are void of bank material. Small, fibrous roots can be very dense and provide greater soil retention compared to the larger root systems of trees (**Figure 6A and 6B**). Estimate a percentage based on the entire bank, then use the "BEHI Score Chart" to record the score for that percentage on the data sheet. See **Figure 6** in Results Section.

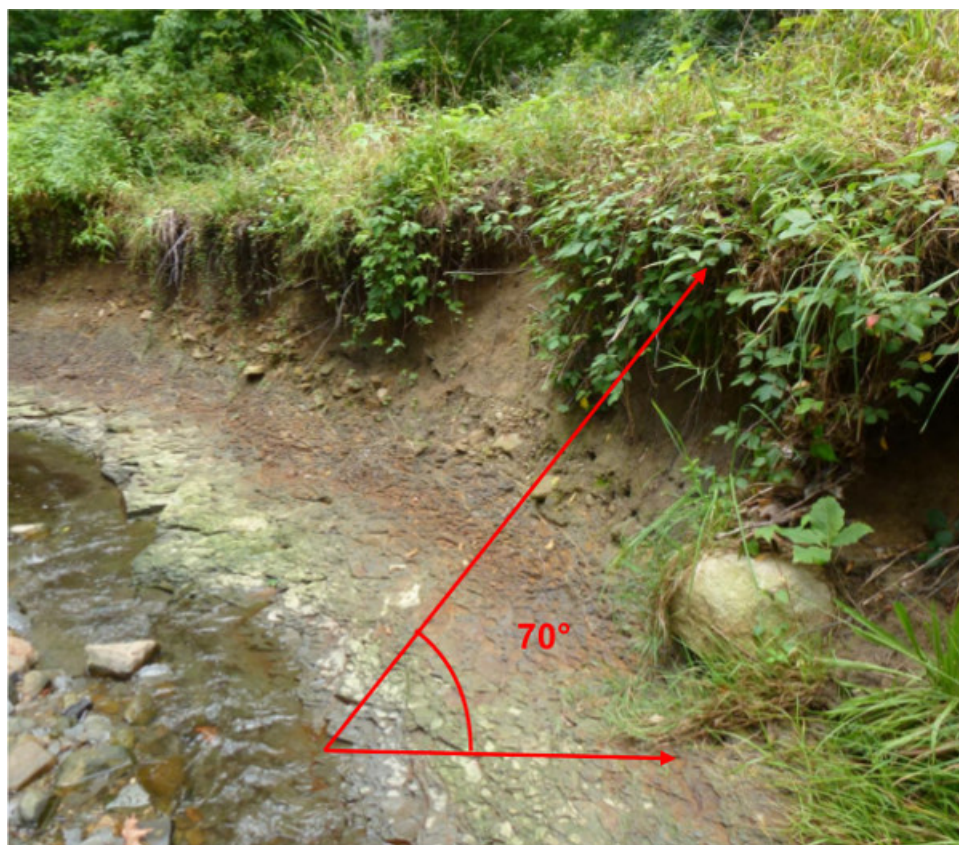
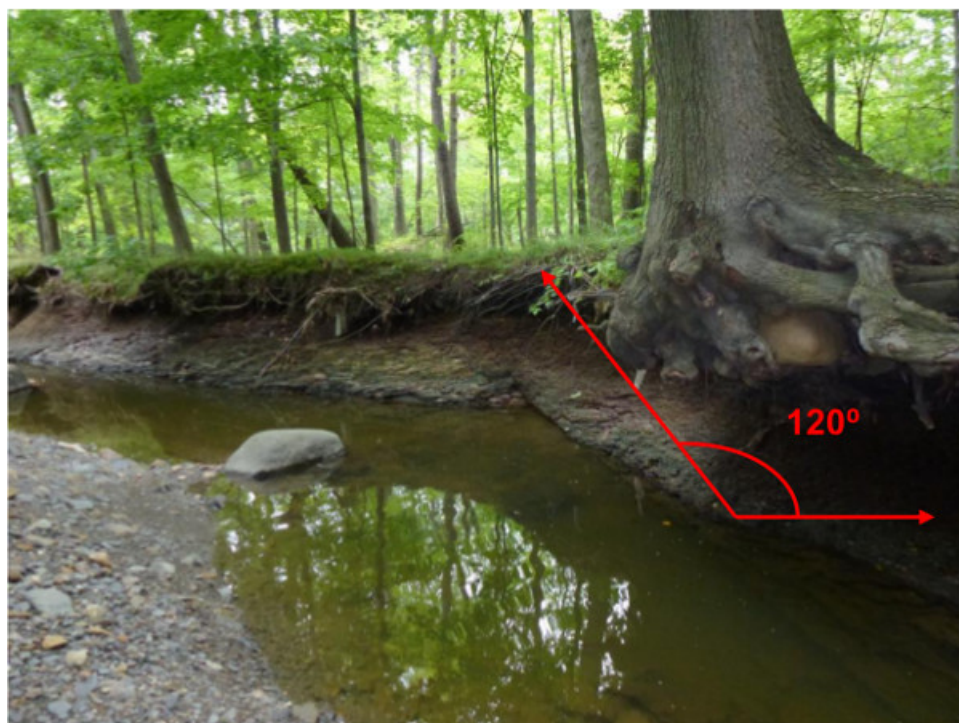
Figure 7. Bank Angle Metric. The bank angle is the angle from the lower bank at the waterline during base flow to the top of the bank. An extremely undercut bank, as shown in the figure can have an angle of 120 degrees or more.

15. Measure the angle from the lower bank at the waterline during base flow to the top of the bank (**Figure 7**). An extremely undercut bank can have an angle up to 120 degrees.

2. Estimate a percentage based on the entire bank, then use the "BEHI Score Chart" to record the score for that percentage on the data sheet. See **Figure 7** in Results Section.

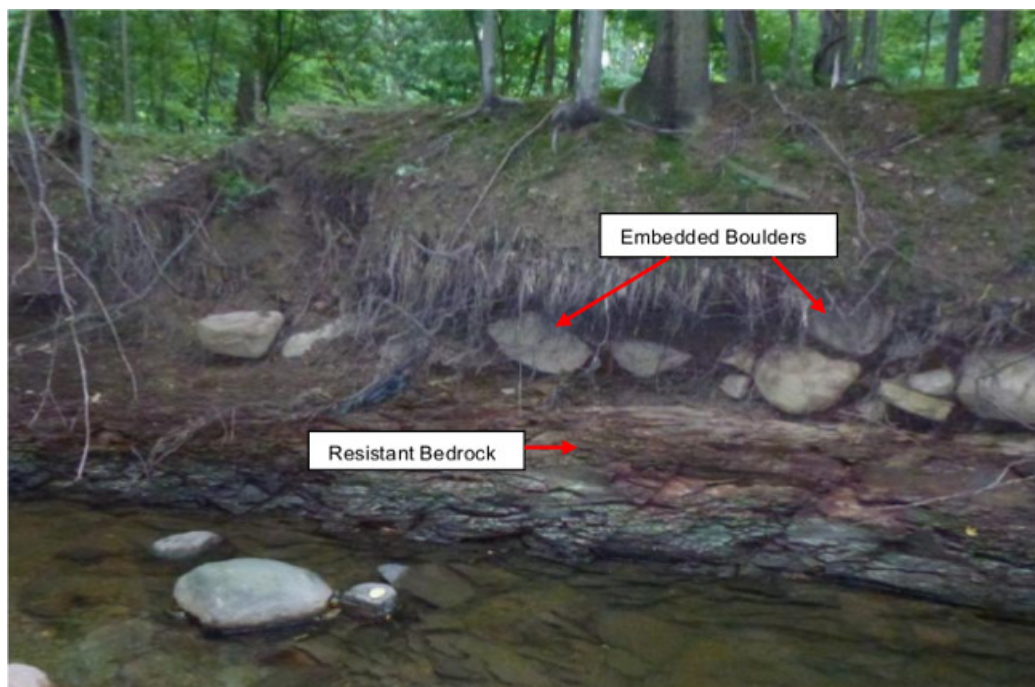
Figure 8. Surface Protection Metric. Surface protection is the amount of stream bank covered and protected by woody debris, rooted vegetation, embedded boulders, revetment, bedrock, etc. The figure shows a bank with resistant bedrock and embedded boulders acting as surface protection.

16. Determine the surface protection present, the amount of streambank covered and protected by woody debris, rooted vegetation, embedded boulders, revetment, bedrock, or other embedded materials that protect the streambank from erosion (**Figure 8**).

1. Visually estimate the percentage of streambank not exposed to erosive forces. Estimate a percentage based on the entire bank, then use the "BEHI Score Chart" to record the score for that percentage on the data sheet. See **Figure 8** in Results Section.

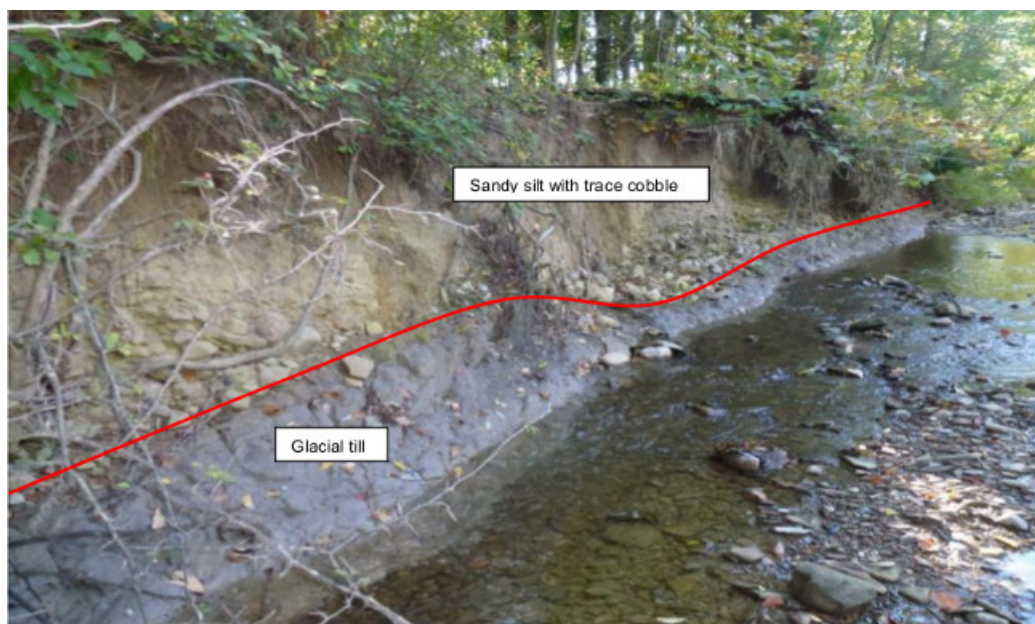
Figure 9. Stratification Metric. A clearly defined layer of stratification with glacial till at the toe and a gravelly sand layer above.

17. Visually determine the number of stratified layers. Stratification refers to a clearly defined horizontal break in geology which has the potential to cause and enhance zones of preferential erosion (**Figure 9**).

1. Record how many layers of stratification are present. See **Figure 9** in Results Section.
18. Make stratification adjustments if increased erosion is occurring due to the stratified layers.

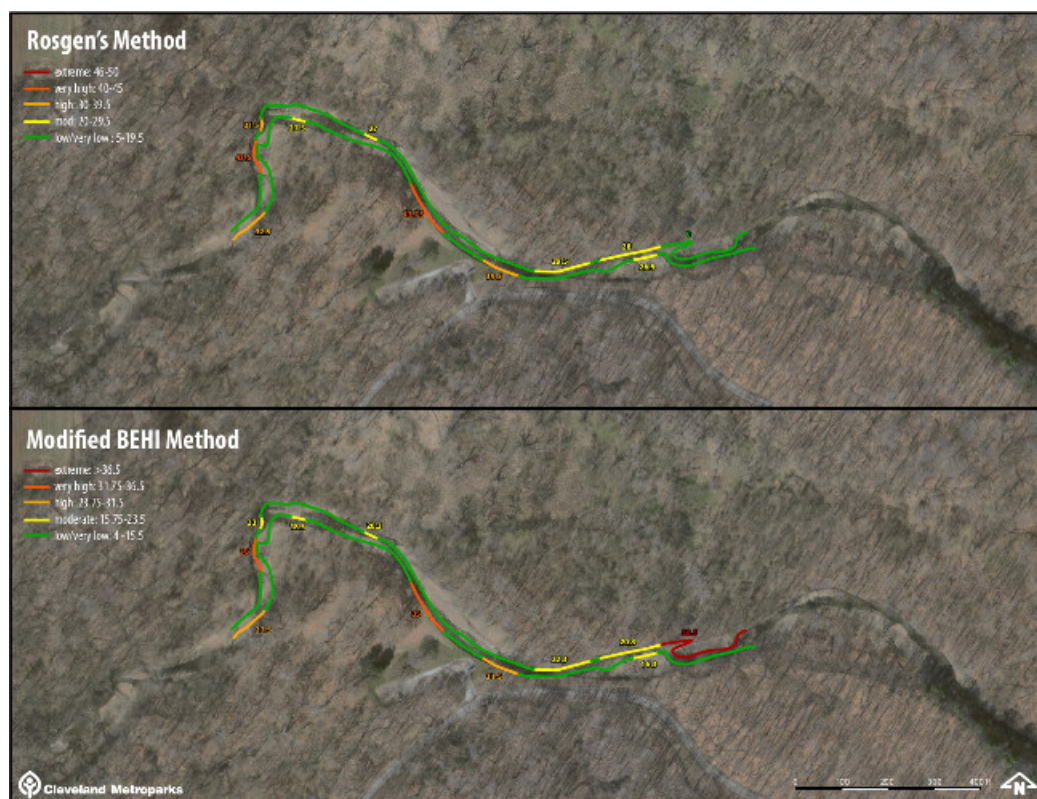
Figure 10. Map comparison. Sagamore Creek map of BEHI ratings, comparing the modified and original protocol. Streambanks that did not pass the Pre-Screening Questionnaire and were not assessed with the modified BEHI protocol, ranked low or very low when assessed with the original BEHI protocol as shown in green above. Sixteen out of the eighteen streambanks assessed with the original BEHI protocol had the same final BEHI rating when assessed with the modified BEHI protocol.

Streambanks that did not pass the Pre-Screening Questionnaire and were not assessed with the modified BEHI protocol, ranked low or very low when assessed with the original BEHI protocol (**Figure 10**). This supports the use of the Pre-Screening Questionnaire as a way to quickly identify streambanks that are experiencing moderate to extreme rates of erosion. See **Figure 10** below.

In general, streambanks assessed were placed in the same final BEHI rating using both the original and the modified BEHI protocol. Sixteen out of the eighteen, or 89% of the streambanks assessed with both BEHI protocols received the same final BEHI rating (**Figure 10**). Streambank 5 scored a 23.0 using the modified BEHI protocol, which is 0.5 points below the cutoff between a moderate and a high BEHI rating (Table 1). Using the original BEHI protocol, the bank scored a 31.25, a high BEHI rating; however, the score was within 1.25 points of the cutoff between a moderate and a high BEHI rating (Table 2). This slight difference in the final BEHI rating can be attributed to the cutoff margins within the BEHI ratings. It is recommended that the final numerical scores are considered, when assessing the overall health of the stream to observe slight variations in the margins of the BEHI ratings (*i.e.*, a high, moderate versus a low, high). See **Tables 1 & 2** below.

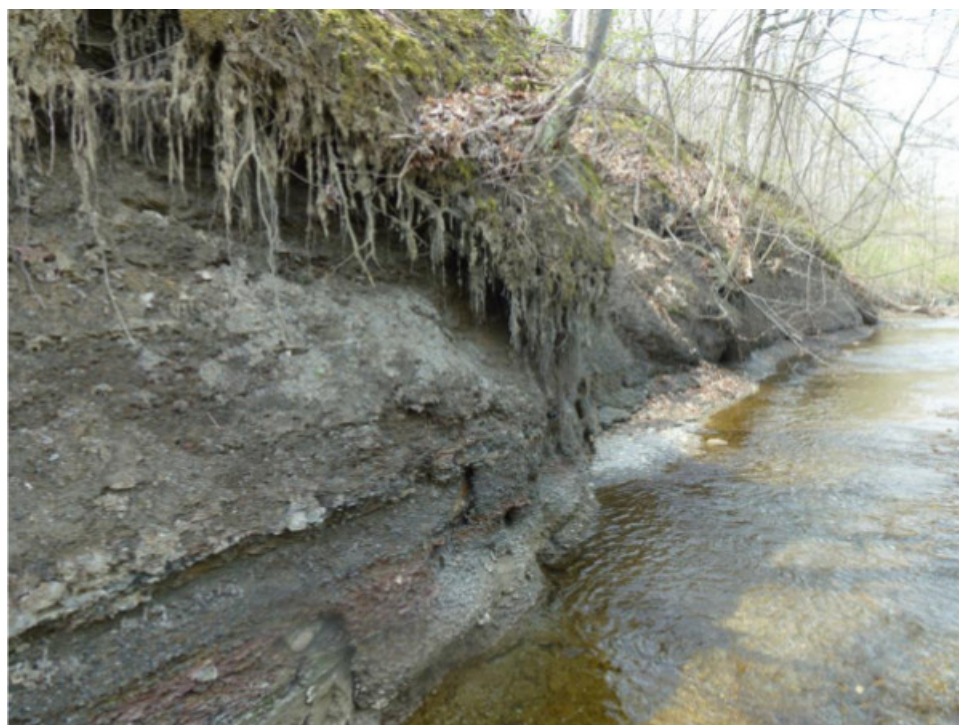
Figure 11. Shale Wall. The weathered shale wall that was unable to be assessed with the original BEHI protocol because bedrock automatically receives a very low BEHI score; however, after completing the modified BEHI protocol, this streambank ranked extreme.

Streambank 18 (**Figure 11**), a weathered shale wall, had a differing BEHI rating between the two protocols because it was unable to be assessed with the original BEHI protocol as bedrock automatically receives a very low BEHI score; however, this streambank failed the Pre-Screening Questionnaire due to the lack of toe protection present (erodible shale does not count as toe protection in our modification of BEHI), a bank height of ten feet or more with 50% or more soil exposure, and more than 50% of the bank was void of rooted vegetation (**Figure 11**); therefore, an assessment using the modified BEHI protocol was necessary. The final BEHI rating, using the modified BEHI protocol was extreme,

due to the steep bank angle, erodible material, lack of a riparian root system extending to the toe, and small amount of surface protection present. See **Figure 11** below.
